Focused Site Inspection Prioritization Report

Highland Park Landfill

USEPA ID No. ILD 981 795 479

September 15, 1995

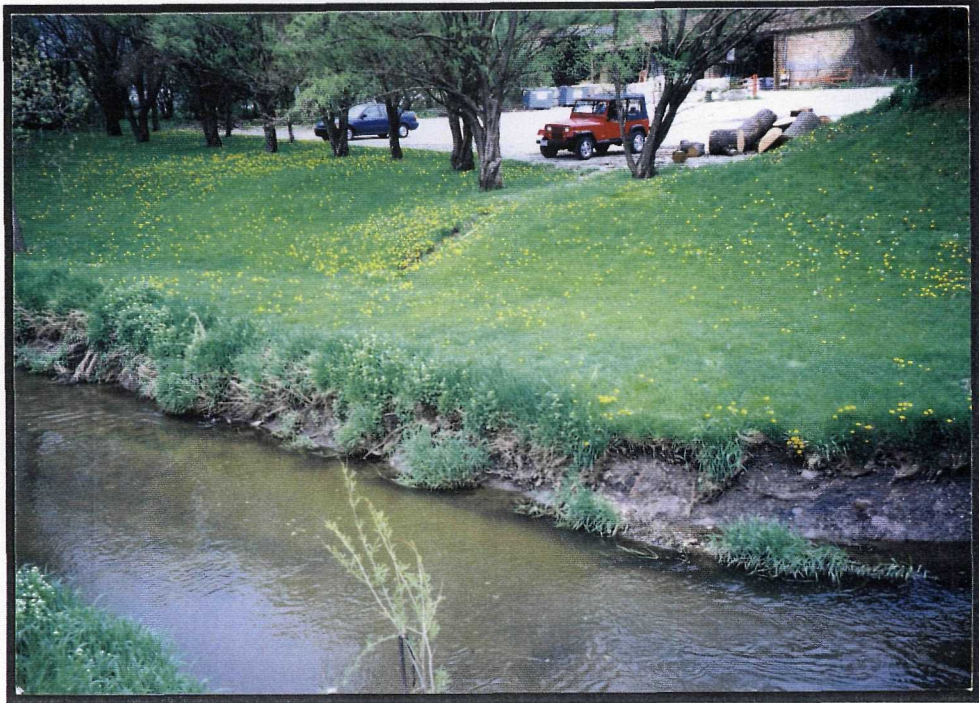
Photo Number: 1

Description: Skokie River from Rt. 22 bridge

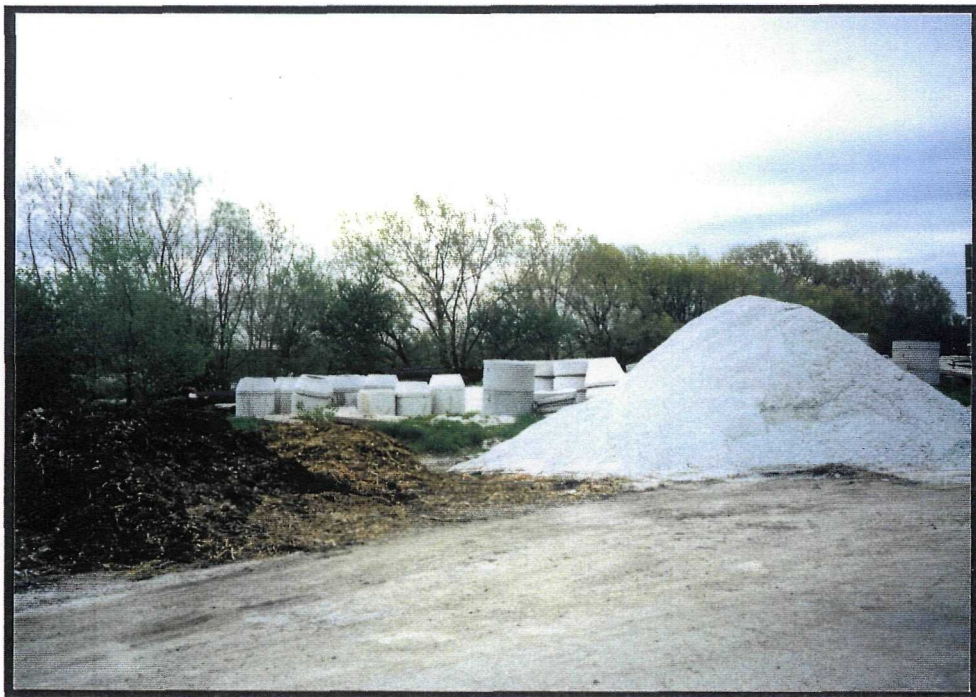
Photo Number: 2

Description: Public works area

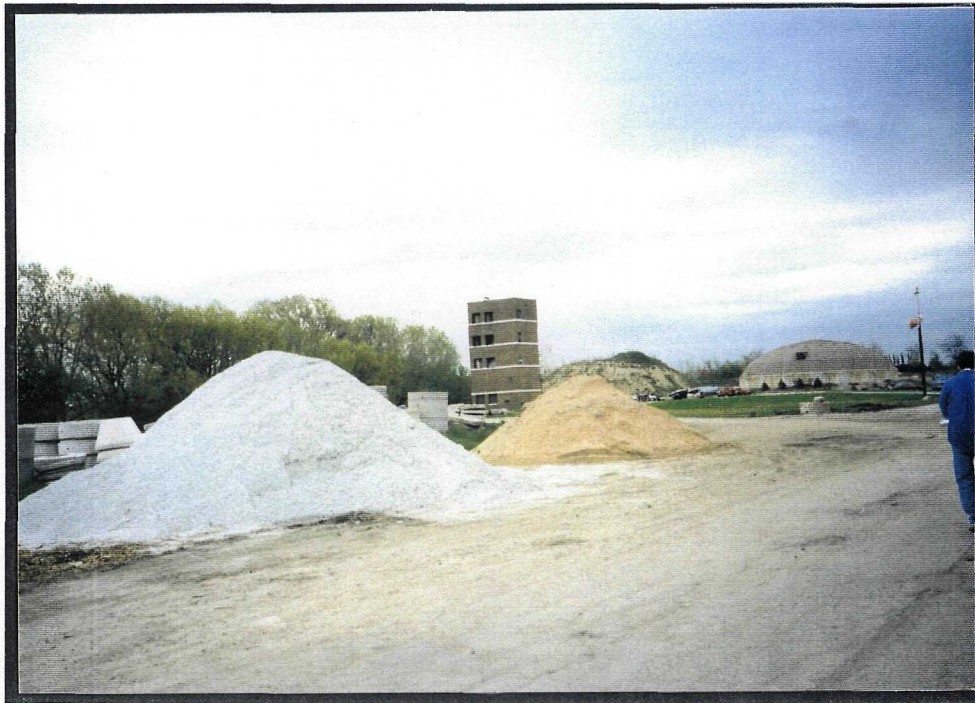
Date: 5/16/95
Time: 1020
Photo Taken By: R. Reints
Photo Number: 3
Site/ILD No.: Highland Park Landfill/ILD981795479
Direction of Photo: Southeast
Description: Public works area

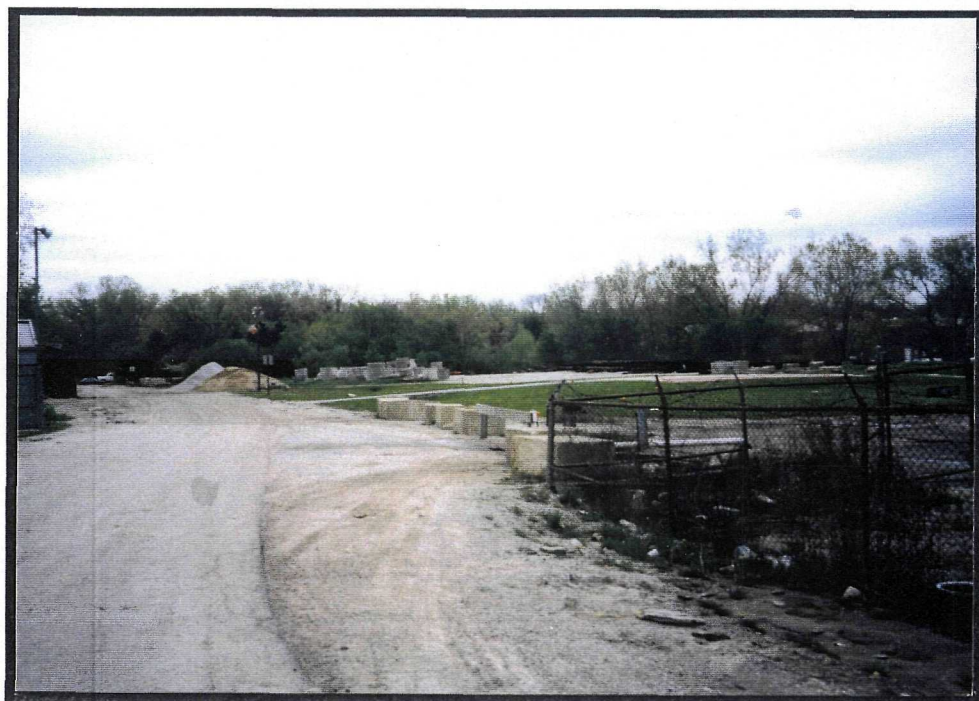
Date: 5/16/95
Time: 1022
Photo Taken By: R. Reints
Photo Number: 4
Site/ILD No.: Highland Park Landfill/ILD981795479
Direction of Photo: North
Description: Public works area

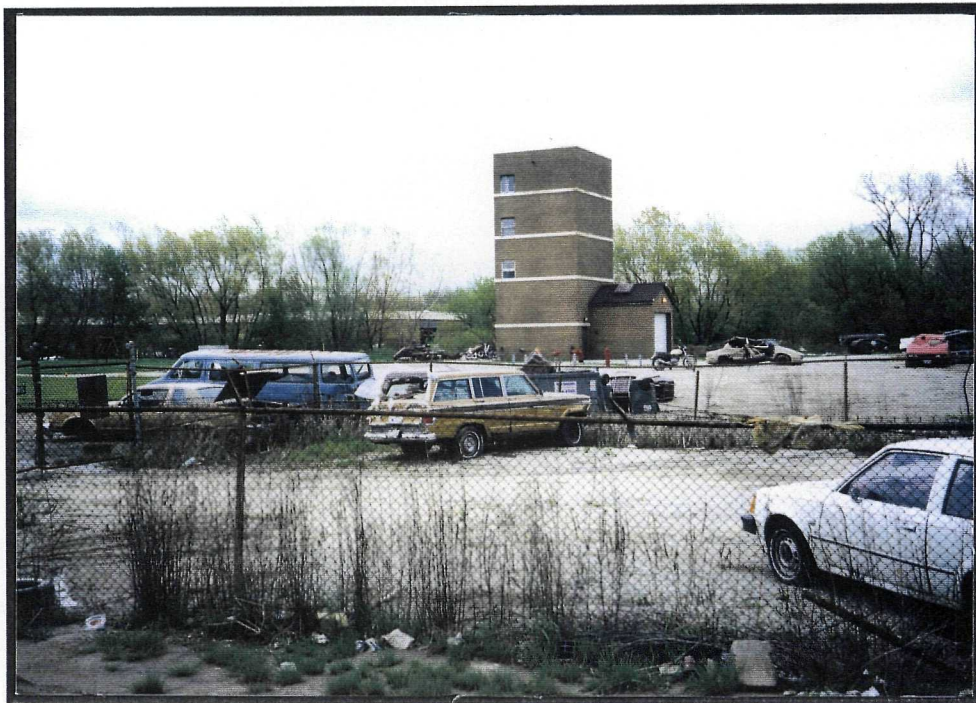
Date: 5/16/95
Time: 1022
Photo Taken By: R. Reints
Photo Number: 5
Site/ILD No.: Highland Park Landfill/ILD981795479
Direction of Photo: East
Description: Public works area

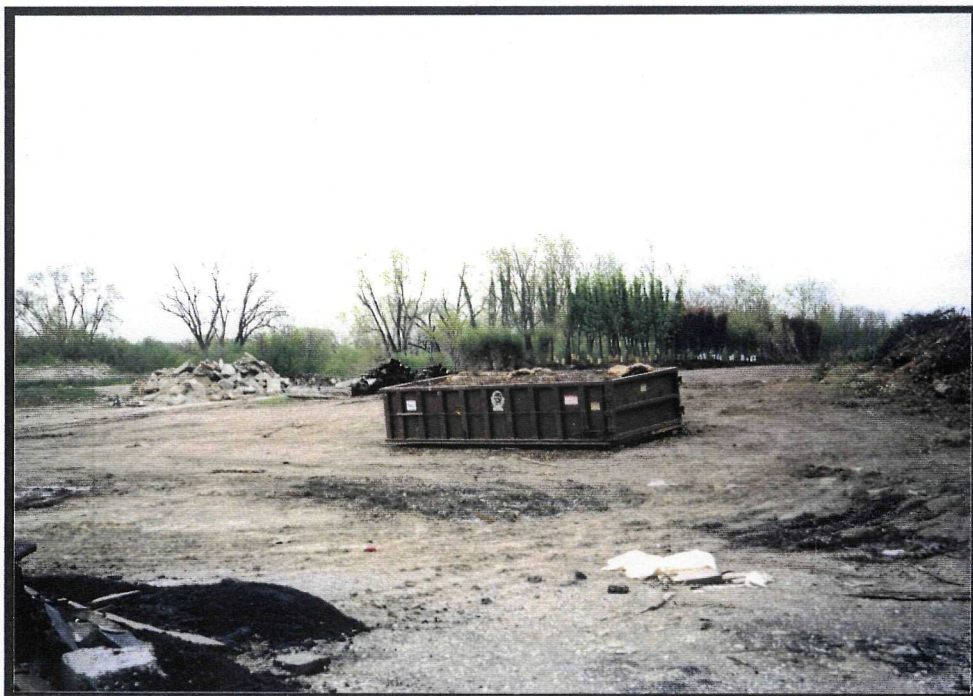
Date: 5/16/95
Time: 1025
Photo Taken By: R. Reints
Photo Number: 6
Site/ILD No.: Highland Park Landfill/ILD981795479
Direction of Photo: South
Description: Public works area

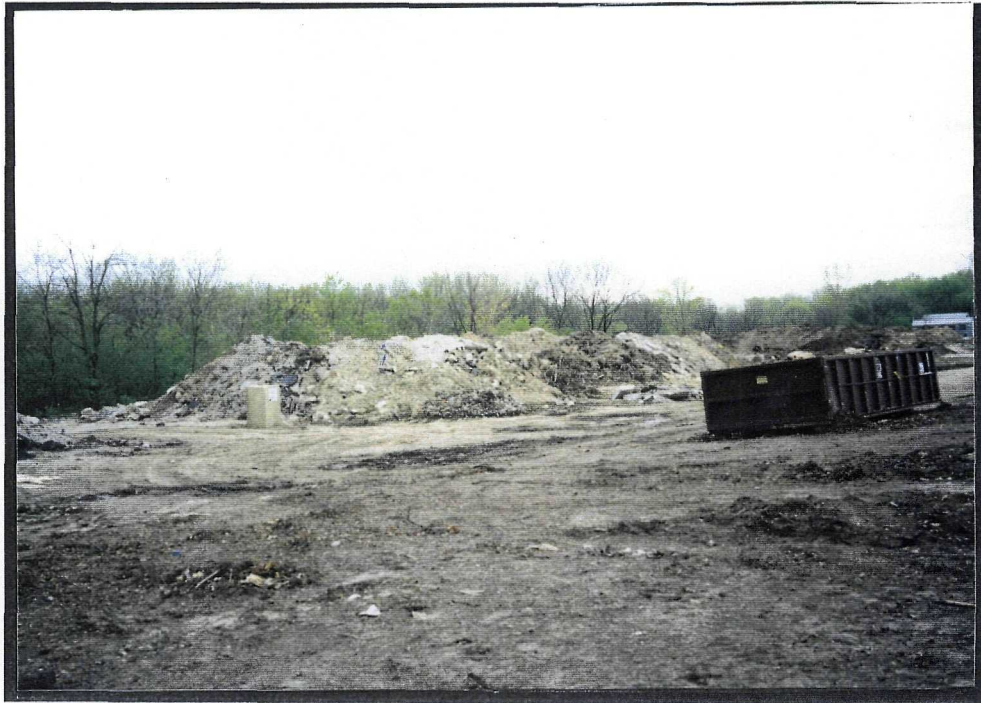
Date: 5/16/95
Time: 1027
Photo Taken By: R. Reints
Photo Number: 7
Site/ILD No.: Highland Park Landfill/ILD981795479
Direction of Photo: North
Description: Public works area

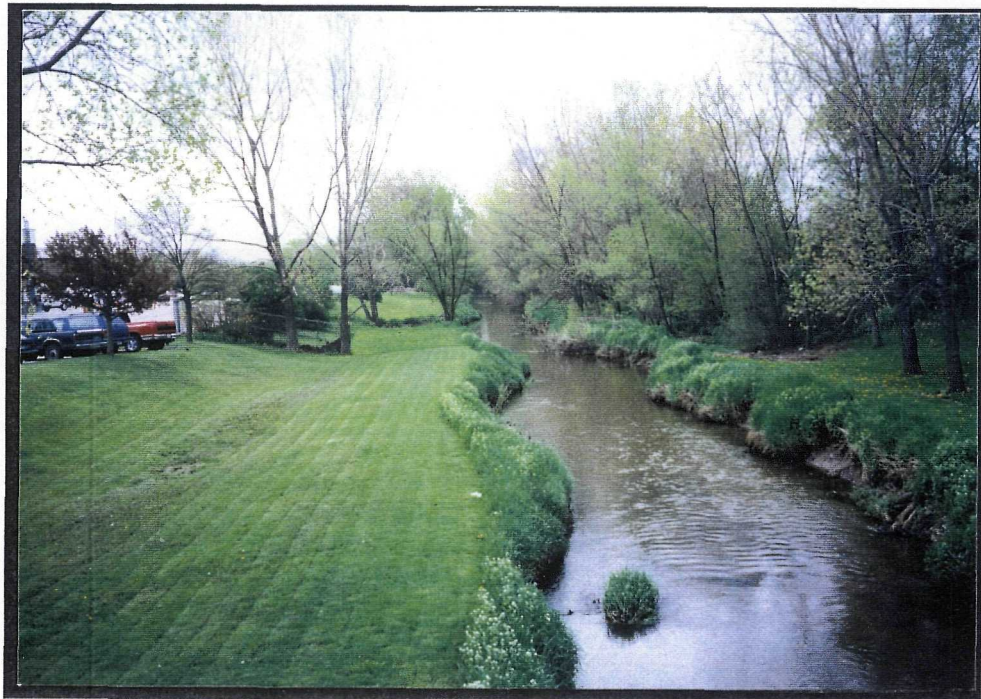
Date: 5/16/95
Time: 1040
Photo Taken By: R. Reints
Photo Number: 8
Site/ILD No.: Highland Park Landfill/ILD981795479
Direction of Photo: South
Description: Skokie River from Half Day Rd.

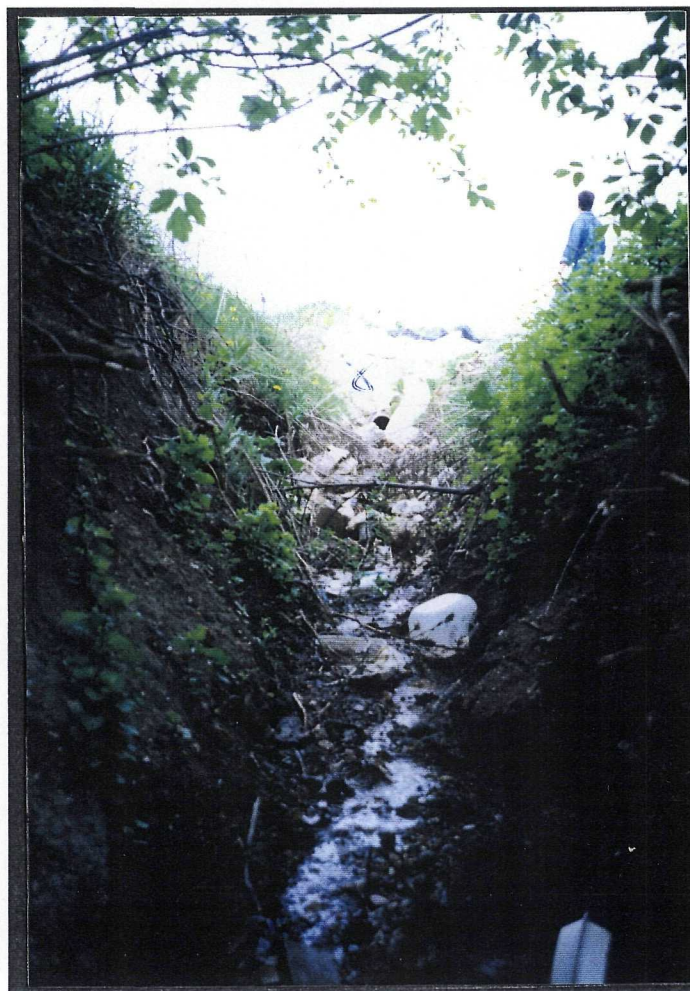
Date: 5/16/95
Time: 1104
Photo Taken By: R. Reints
Photo Number: 9
Site/ILD No.: Highland Park Landfill/ILD981795479
Direction of Photo: West
Description: Ravine flowing into Skokie River

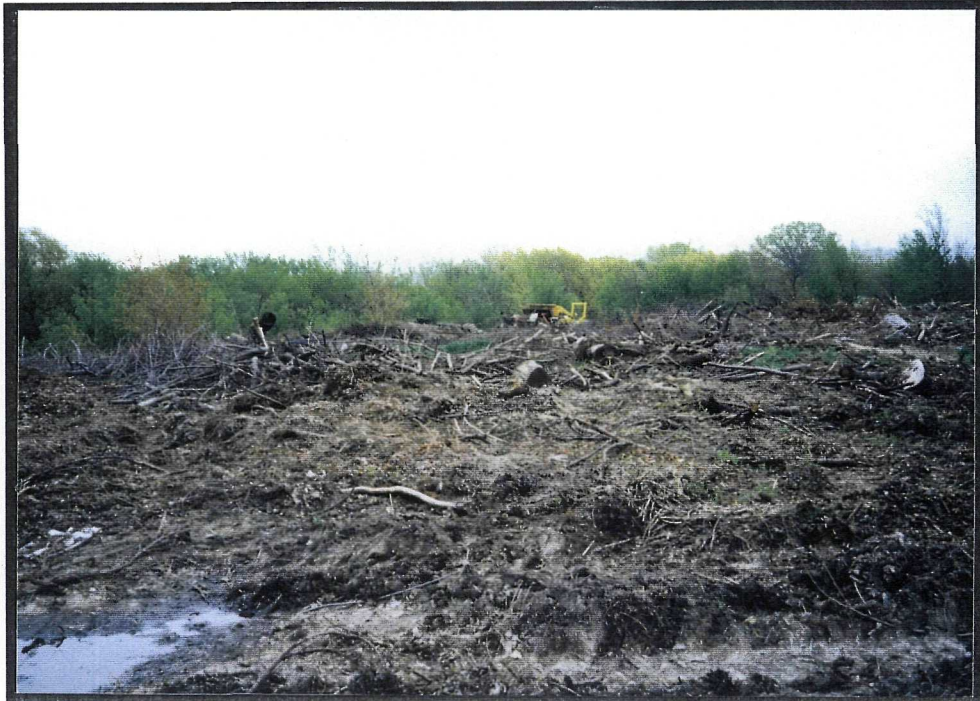
Photo Number: 10

Description: Wood/landscape waste

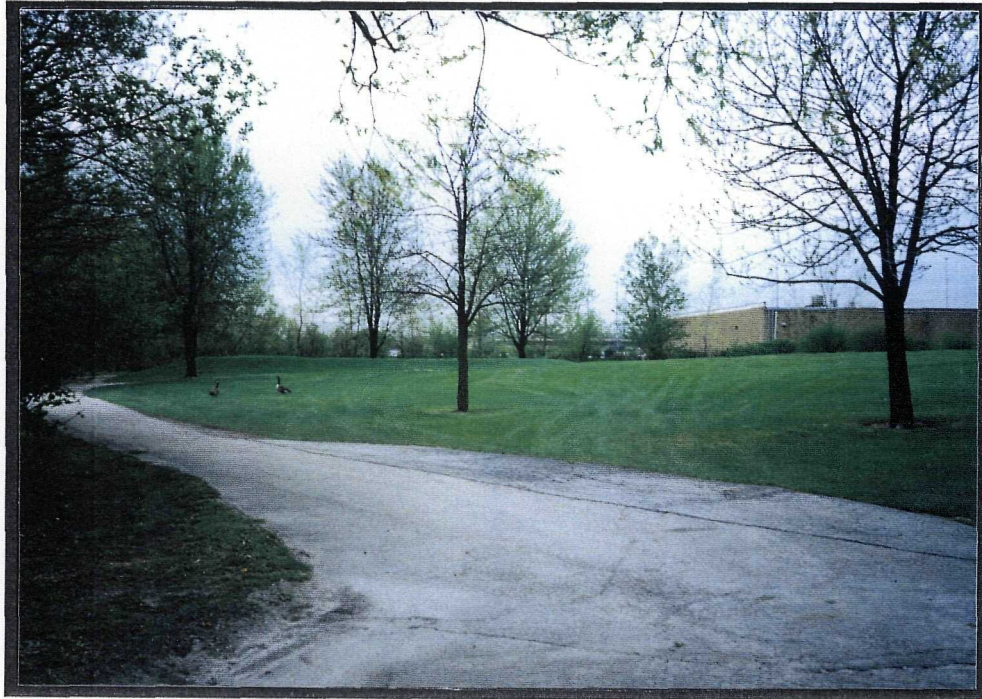
Date: 5/16/95
Time: 1130
Photo Taken By: R. Reints
Photo Number: 11
Site/ILD No.: Highland Park Landfill/ILD981795479
Direction of Photo: Southwest
Description: South end of site

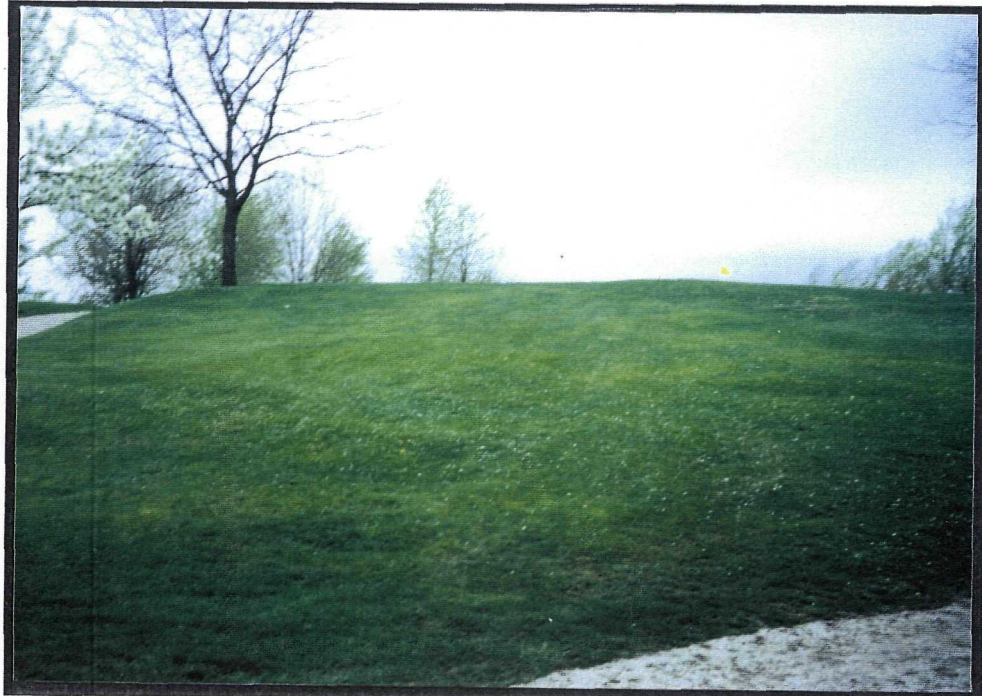
Date: 5/16/95
Time: 1130
Photo Taken By: R. Reints
Photo Number: 12
Site/ILD No.: Highland Park Landfill/ILD981795479
Direction of Photo: West
Description: Green area, drains to Skokie River

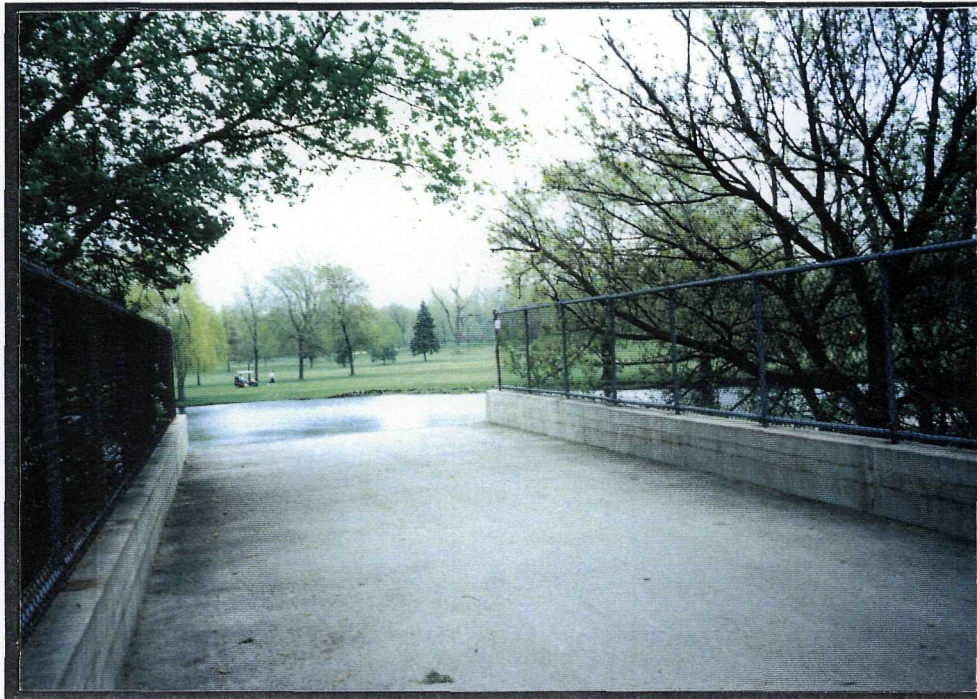
Date: 5/16/95
Time: 1130
Photo Taken By: R. Reints
Photo Number: 13
Site/ILD No.: Highland Park Landfill/ILD981795479
Direction of Photo: East
Description: Golf course east of site

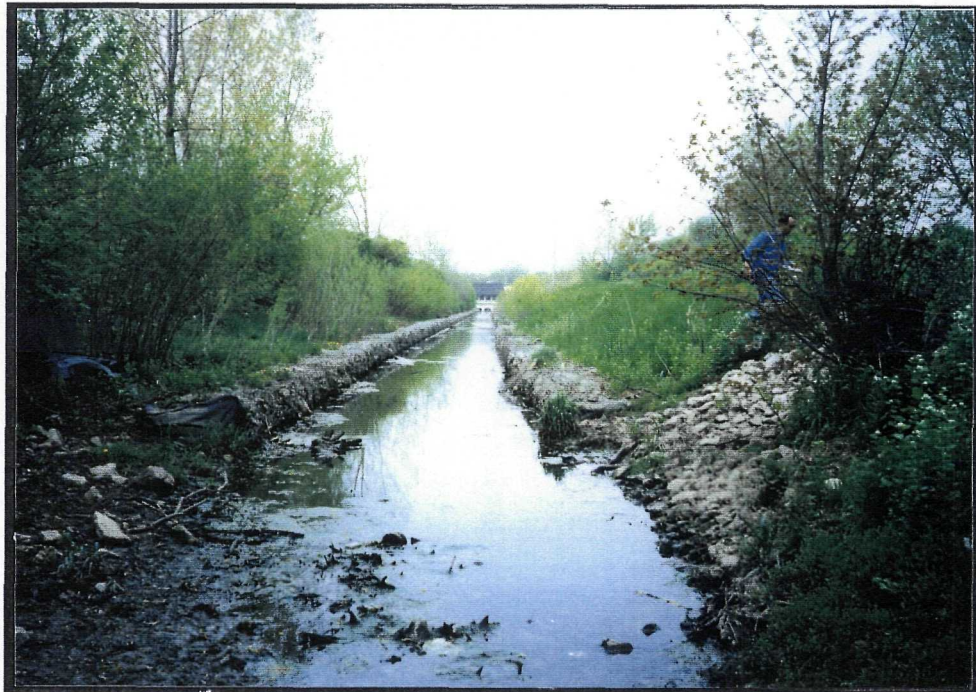
Date: 5/16/95
Time: 1134
Photo Taken By: R. Reints
Photo Number: 14
Site/ILD No.: Highland Park Landfill/ILD981795479
Direction of Photo: West
Description: Drainage ditch at Southern boundary

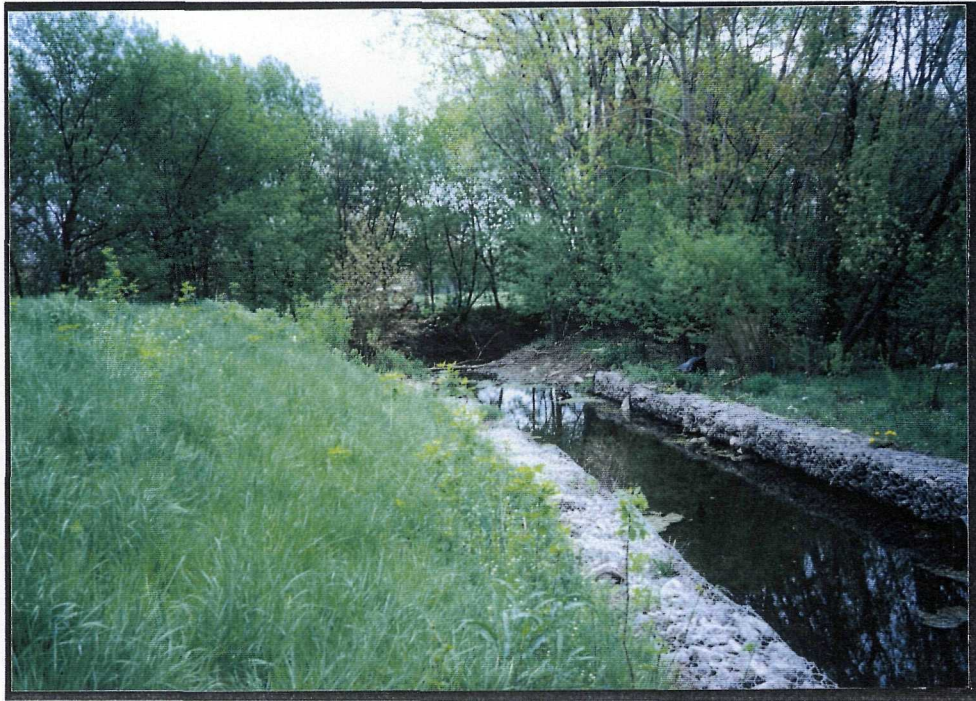
Date: 5/16/95
Time: 1135
Photo Taken By: R. Reints
Photo Number: 15
Site/ILD No.: Highland Park Landfill/ILD981795479
Direction of Photo: East
Description: Drainage ditch enters Skokie River

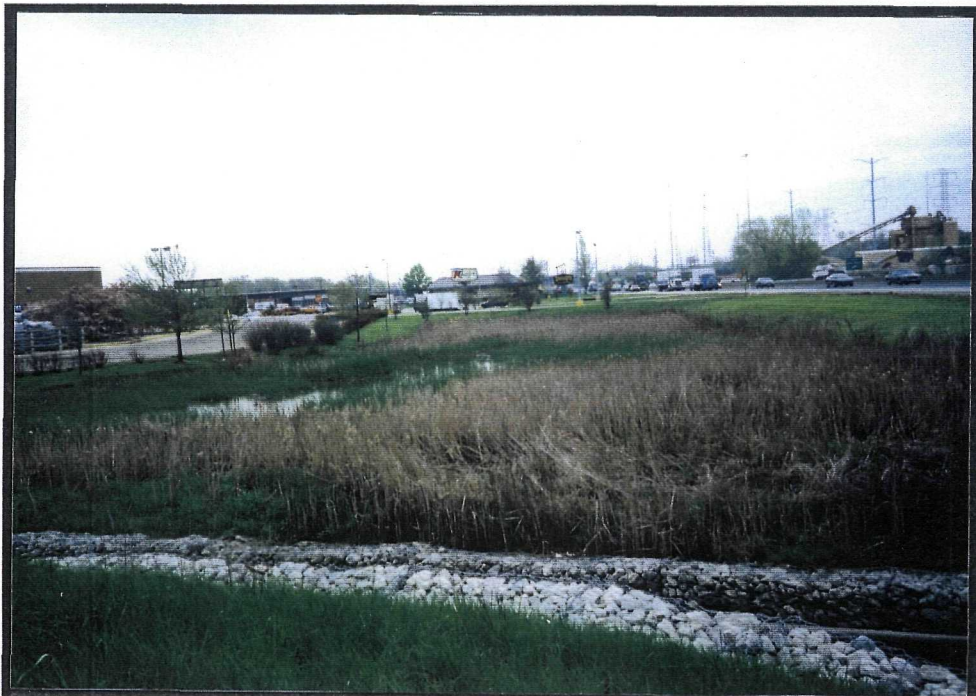
Date: 5/16/95
Time: 1140
Photo Taken By: R. Reints
Photo Number: 16
Site/ILD No.: Highland Park Landfill/ILD981795479
Direction of Photo: Southwest
Description: Southwest corner of site

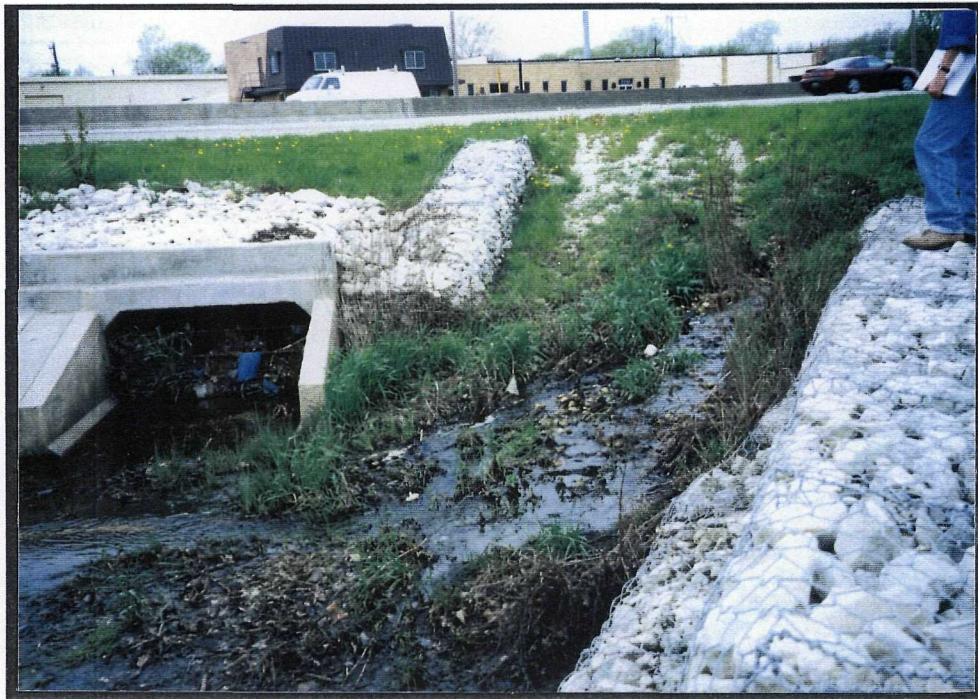
Date: 5/16/95
Time: 1141
Photo Taken By: R. Reints
Photo Number: 17
Site/ILD No.: Highland Park Landfill/ILD981795479
Direction of Photo: Northwest
Description: Drainage under Rt. 41

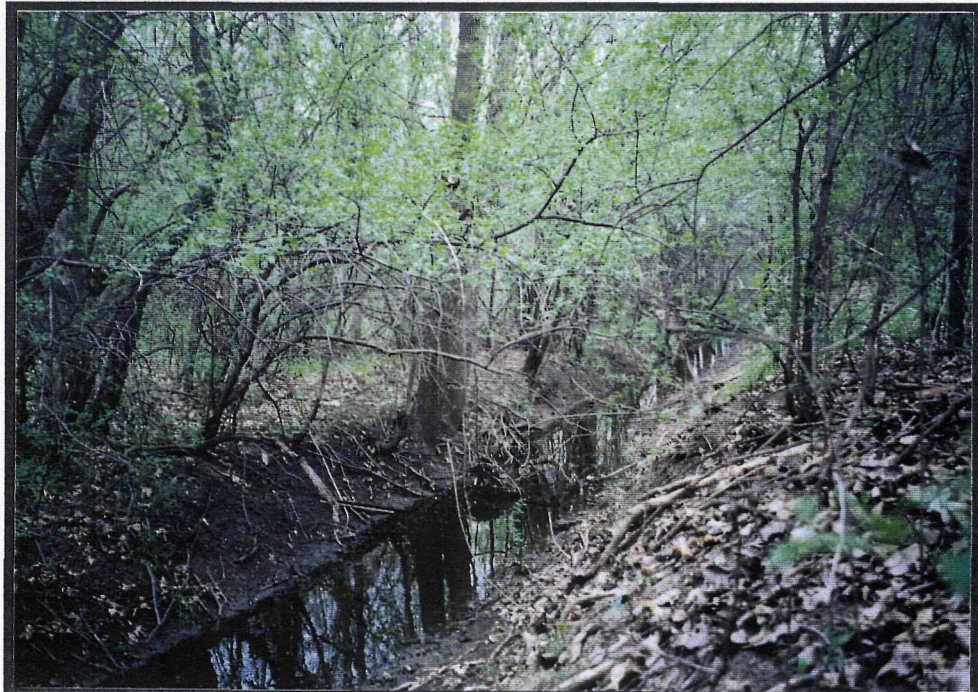
Date: 5/16/95
Time: 1150
Photo Taken By: R. Reints
Photo Number: 18
Site/ILD No.: Highland Park Landfill/ILD981795479
Direction of Photo: North
Description: Stream along west boundary

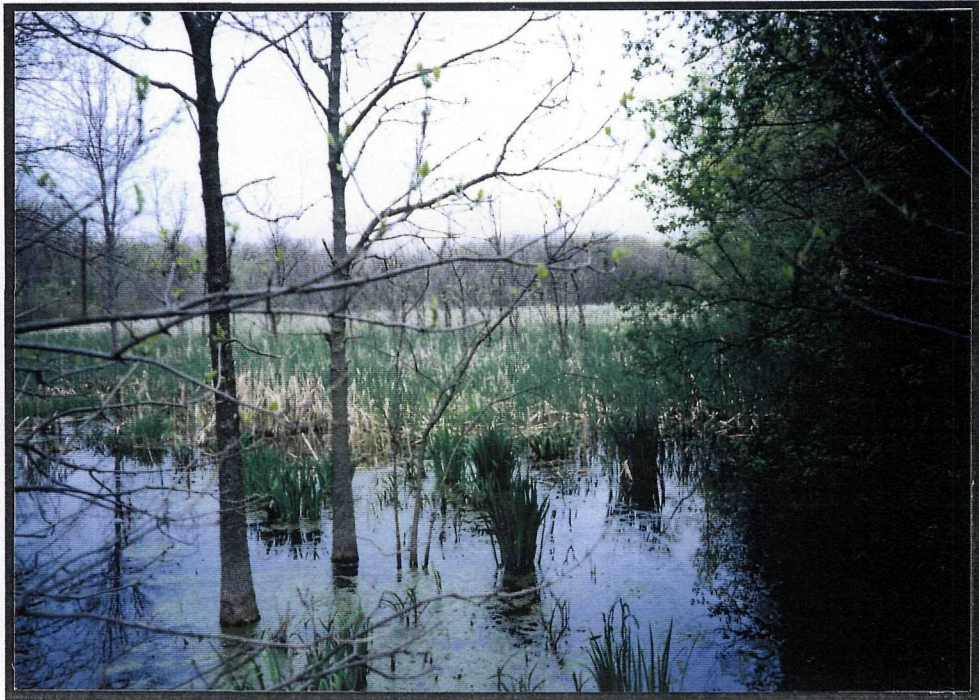
Date: 5/16/95
Time: 1153
Photo Taken By: R. Reints
Photo Number: 19
Site/ILD No.: Highland Park Landfill/ILD981795479
Direction of Photo: North/northwest
Description: Wetland west of site

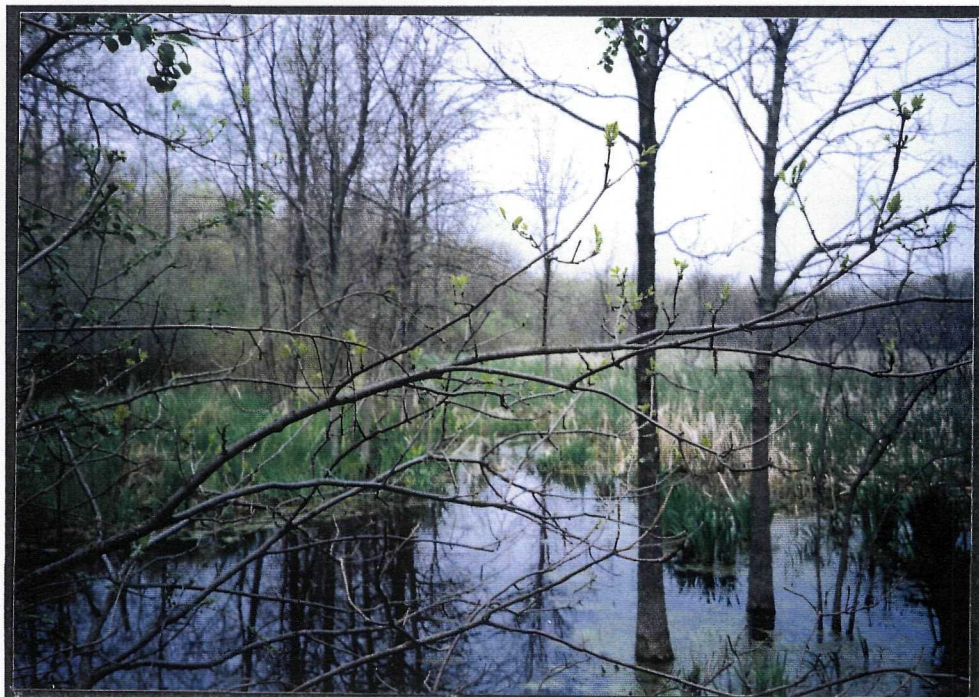
Date: 5/16/95
Time: 1153
Photo Taken By: R. Reints
Photo Number: 20
Site/ILD No.: Highland Park Landfill/ILD981795479
Direction of Photo: North/northwest
Description: Wetland west of site

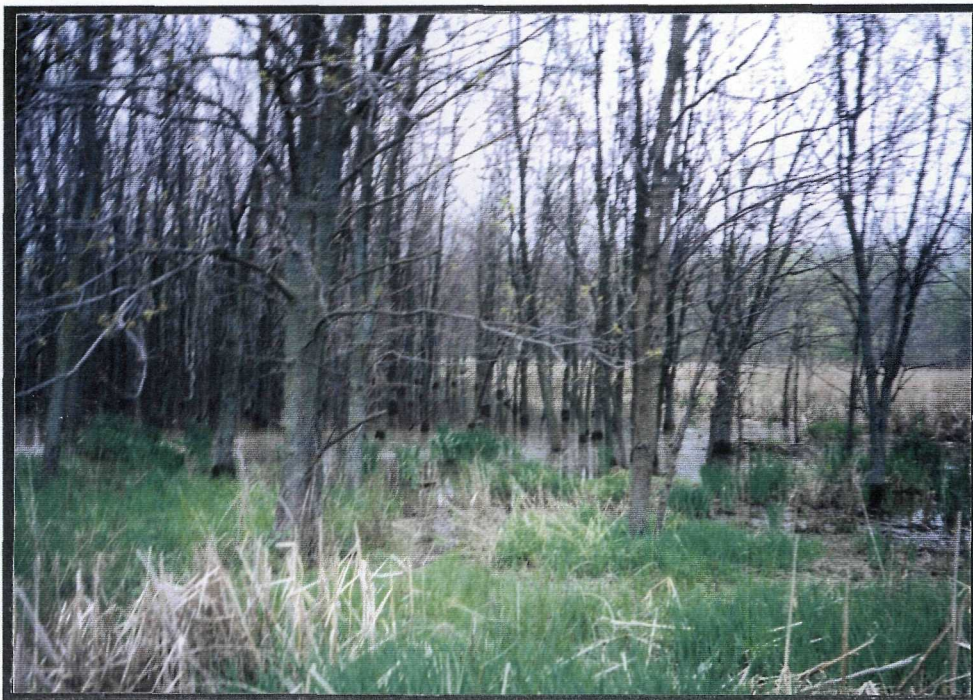
Date: 5/16/95
Time: 1205
Photo Taken By: R. Reints
Photo Number: 21
Site/ILD No.: Highland Park Landfill/ILD981795479
Direction of Photo: South/southwest
Description: Wetland west of site

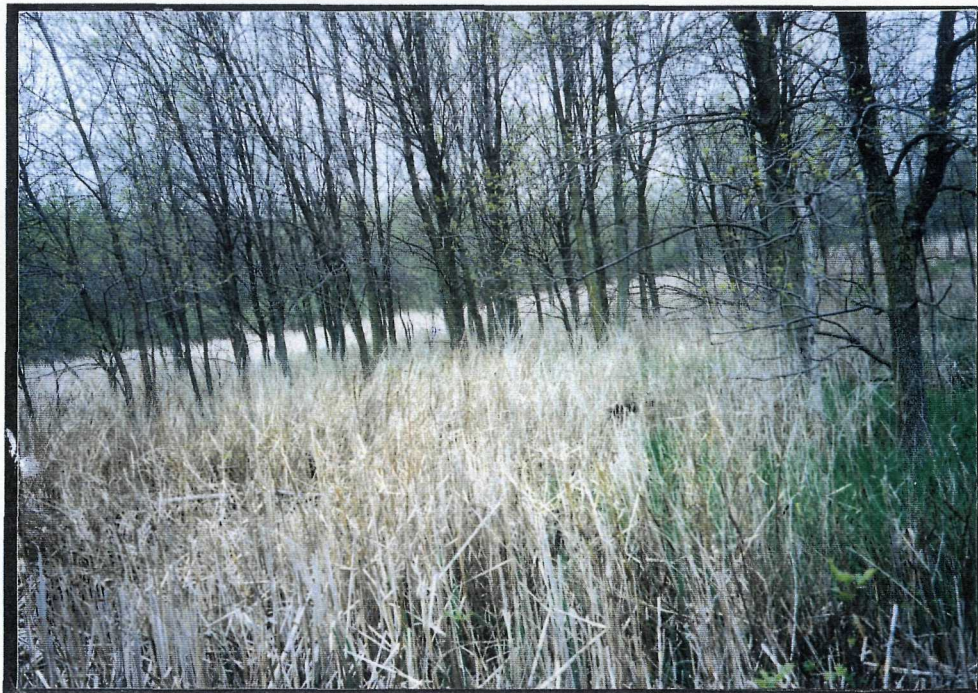
Date: 5/16/95
Time: 1206
Photo Taken By: R. Reints
Photo Number: 22
Site/ILD No.: Highland Park Landfill/ILD981795479
Direction of Photo: North
Description: Wetland area west of the site

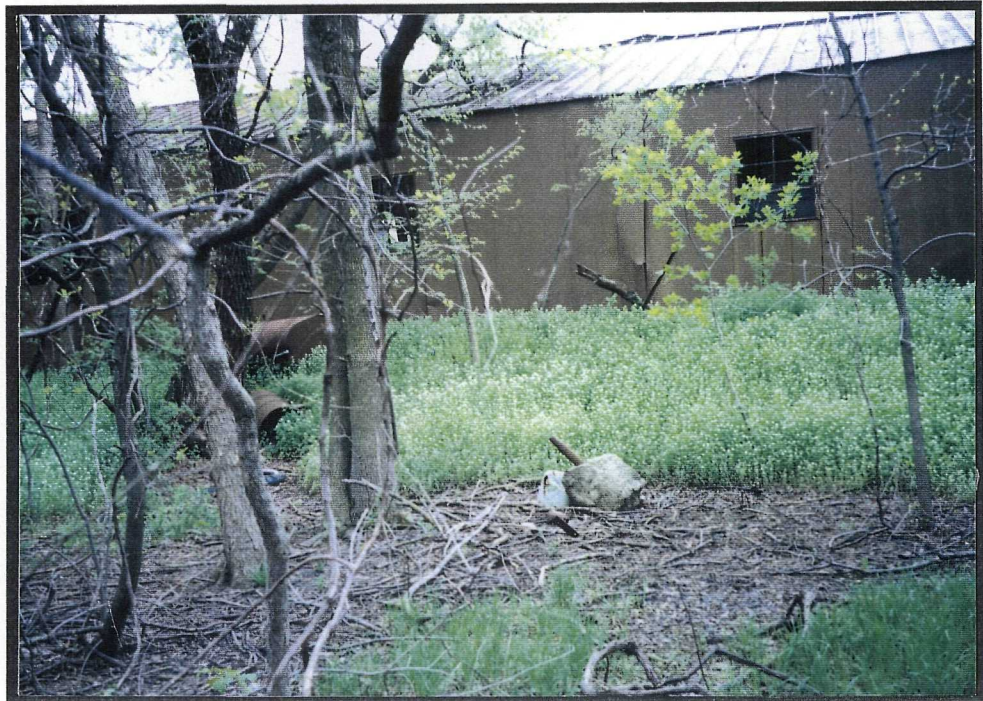
Photo Number: 23

Description: Shed, rusted drum, tank
